Diagnosis and Solutions for Bank Erosion Problems

This fact sheet describes frequently observed bank erosion problems and recommends installations to correct each situation. If major problems exist, experts should be consulted.

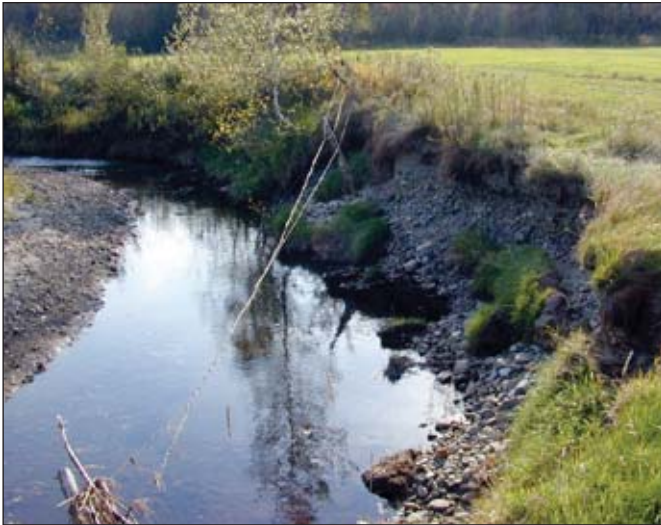
Photo 1: The erosive power of water
Source: Luc Lemieux, MAPAQ

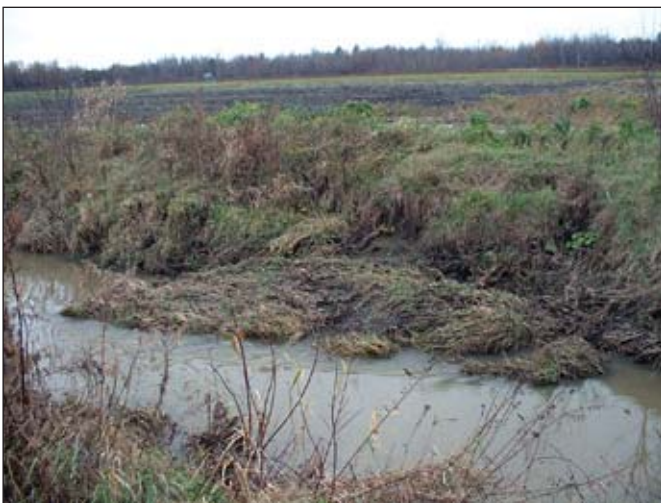
Photo 2: The effect of gravity
Source: Robert Beaulieu, MAPAQ

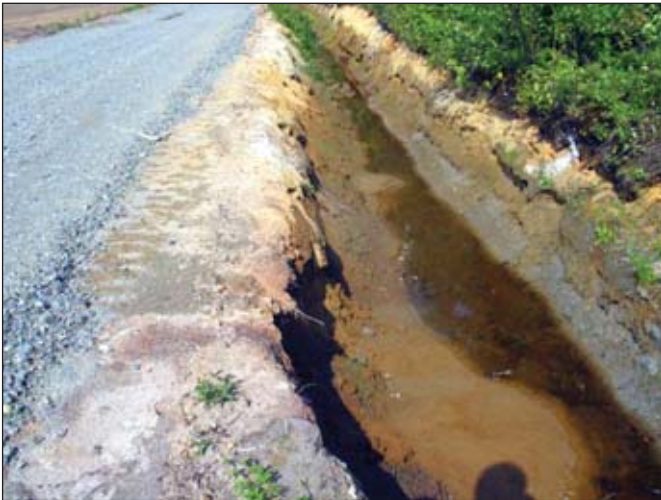
Photo 3: Piping caused by excavation of a stream in soil with an elevated water table
Source: Victor Savoie, MAPAQ

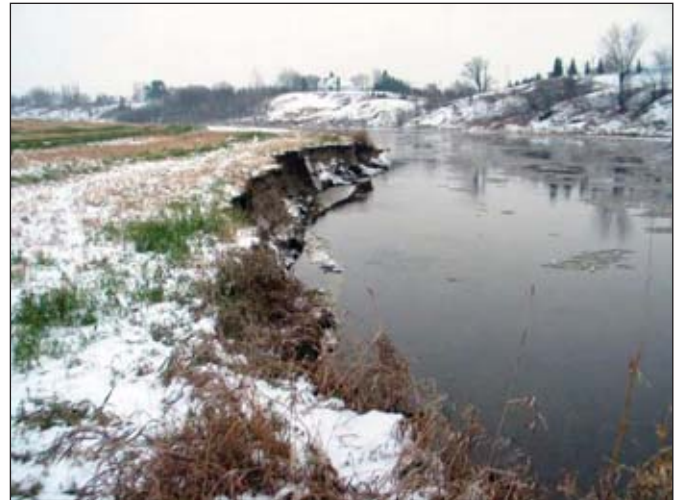
Photo 4: The erosive power of water
Source: Victor Savoie, MAPAQ

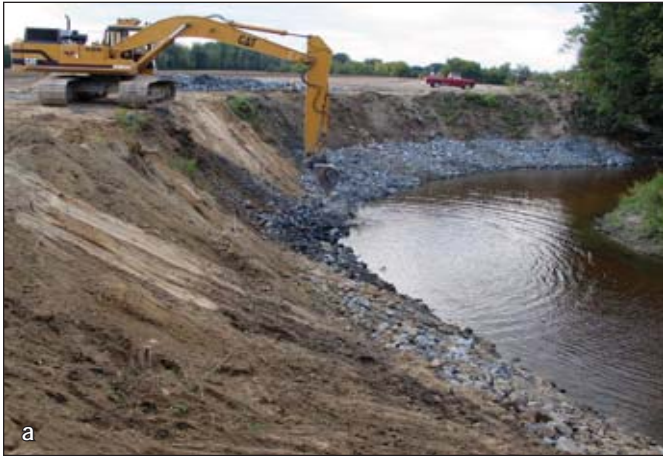
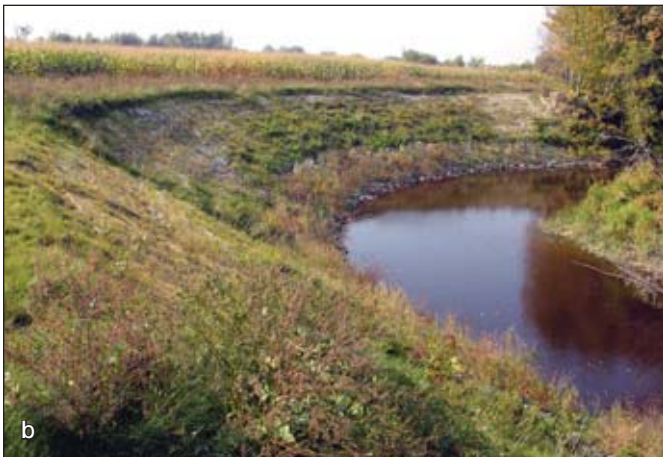
Photos 5 (a, b): Installations in a bend
Source: Mikael Guillou MAPAQ

- In all cases, plant shrubs and/or perennials at the top of the bank.
- Reduce water flow by installing energy dissipating sills.
- In bends:
 - Round out bends before establishing protection.
 - Build rock or willow pole groins (other techniques also exist) to divert the current toward the centre of the stream.

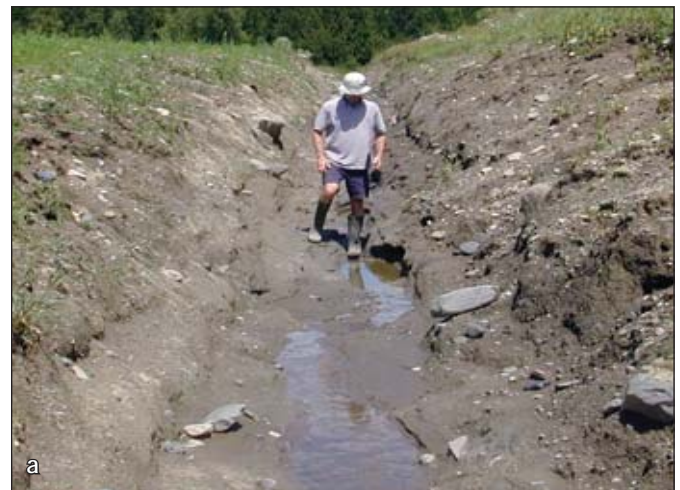
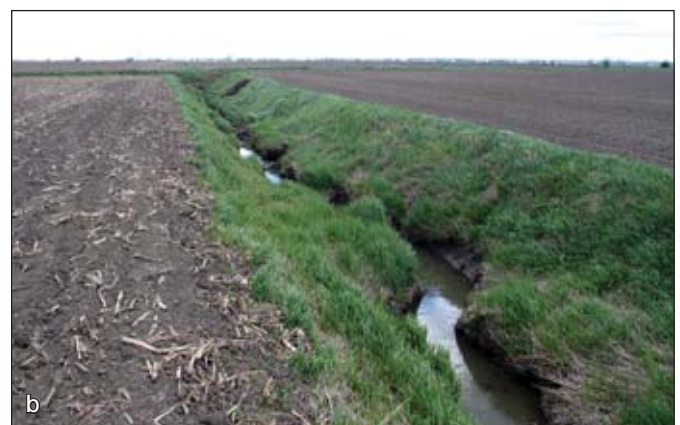
Photos 6 (a and b): Downcutting
Source: Luc Lemieux and Mikael Guillou, MAPAQ

- Streambed deepening (compared with previous longitudinal profiles).
- Signs of meanders and sedimentation in the bed during low-flow periods.
- Rapid flow, where water is present.
- If a culvert is present: a vertical wall at the culvert outlet (downstream).
- Exposed roots (to differentiate from undercutting).
- Slumping of both banks, particularly along a straight line.
- No aquatic vegetation or sedimentation.
- Steep slope and deep soil (no bedrock).
- Soil layer change in the streambed.
- Formation of a deepened bed in the centre of the stream, with vertical banks (see Figure 4 and Photo 6).

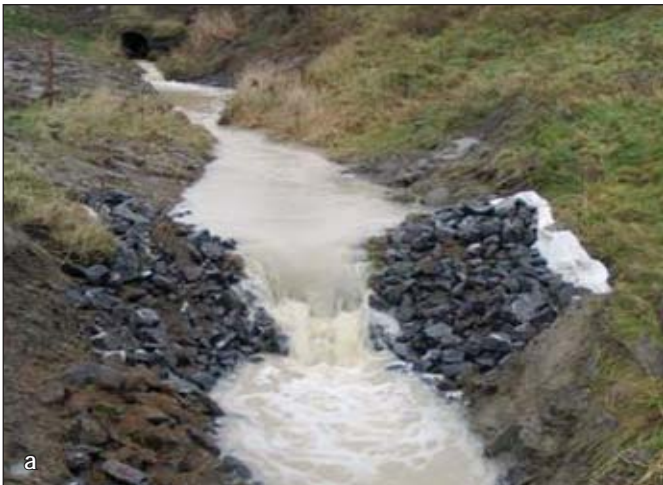
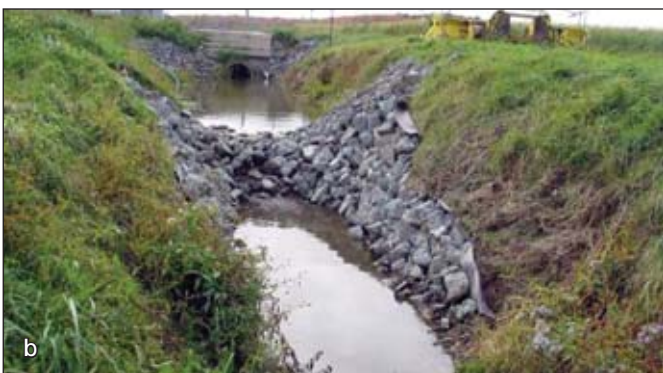
Photos 7 (a and b): Energy dissipating sill
Source: Jacques Goulet and Victor Savoie, MAPAQ

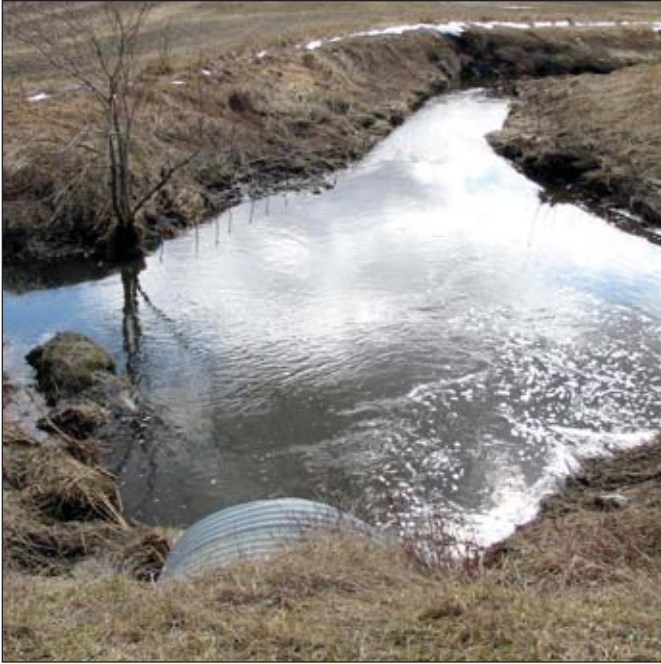
Photo 8: Widening of the streambed downstream of a culvert
Source: Mikael Guillou, MAPAQ

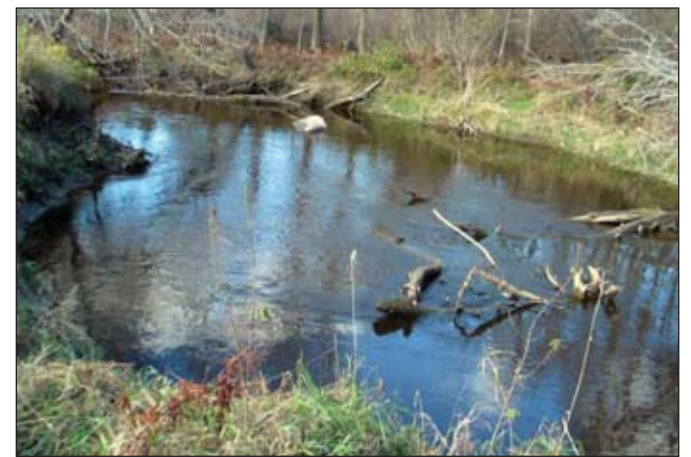
Photo 10: Bank erosion caused by an obstruction in the streambed.
Source: Victor Savoie, MAPAQ

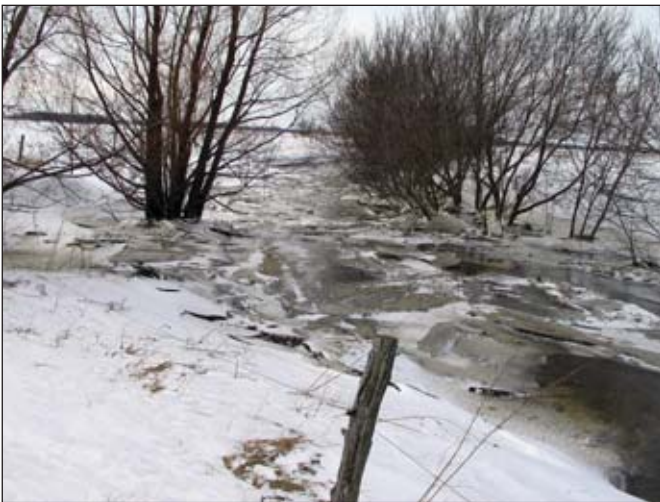
Photo 11: Ice erosion
Source: Mikael Guillou, MAPAQ

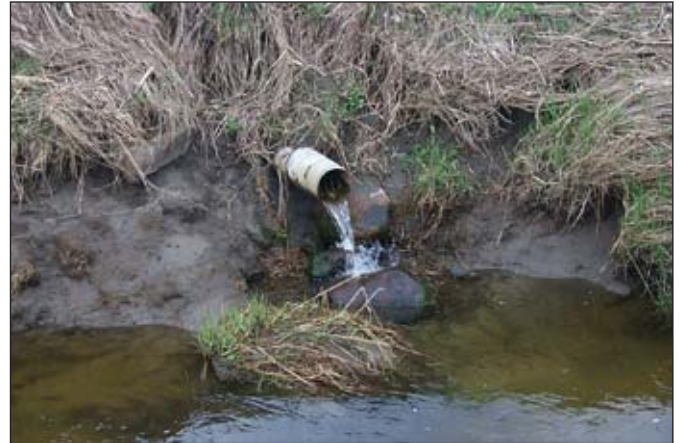
Photo 12: Erosion at a drain outlet
Source: Mikael Guillou, MAPAQ

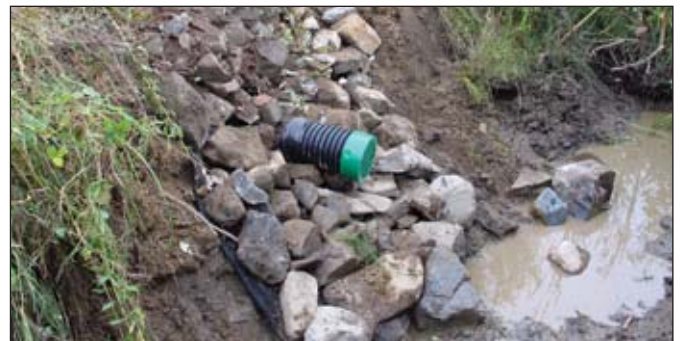
Photo 13: Erosion protection at a drain outlet
Source: Mikael Guillou, MAPAQ

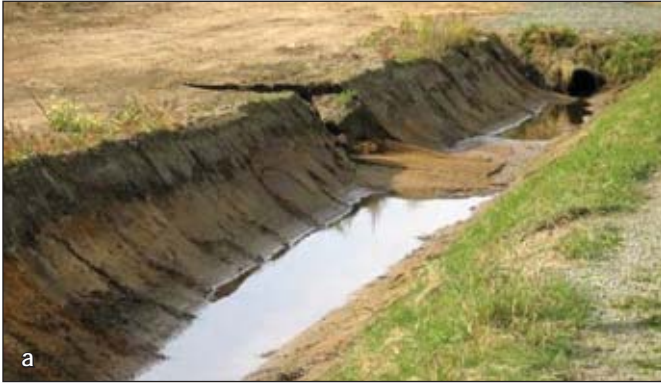
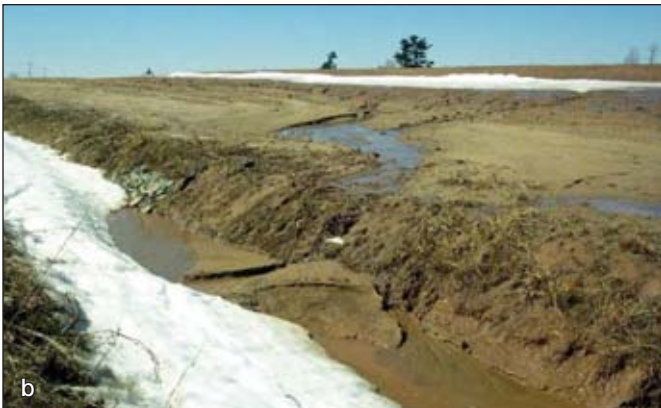
Photo 14 (a and b): Gullying originating in a field.
Source: Victor Savoie, MAPAQ

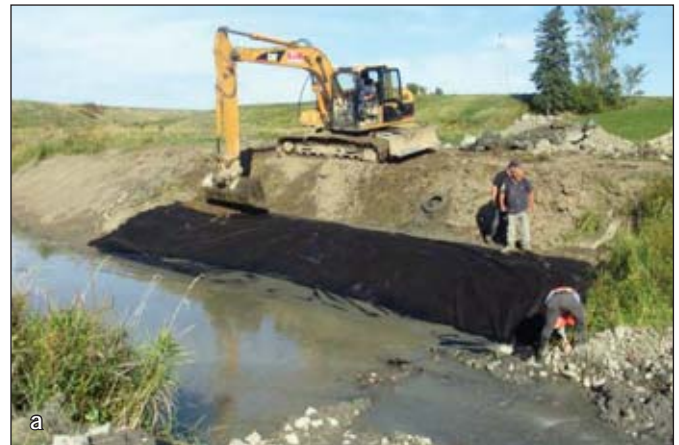
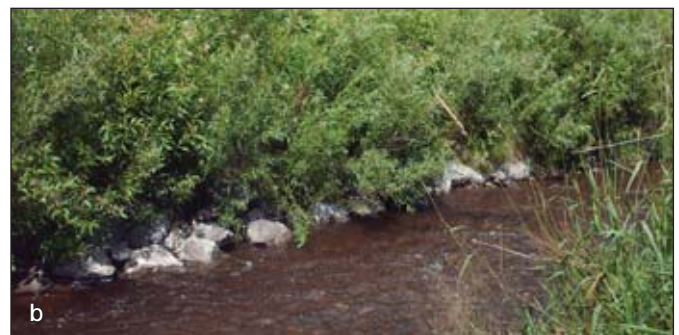
Photos 16 (a and b): Bank stabilization
Source: Victor Savoie, Ghislain Poisson, MAPAQ

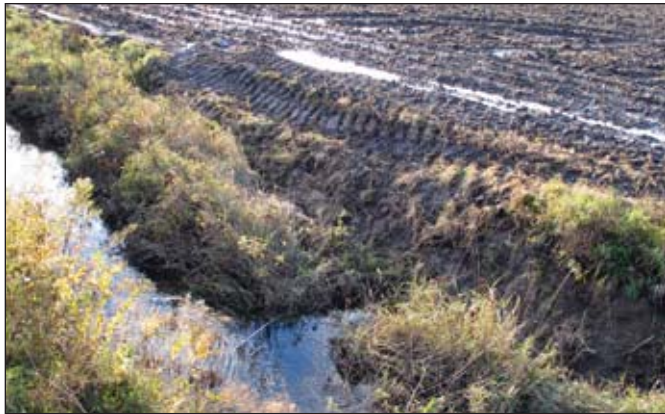
Photo 17: Failure caused by an excessive load
Source: Mikael Guillou, MAPAQ

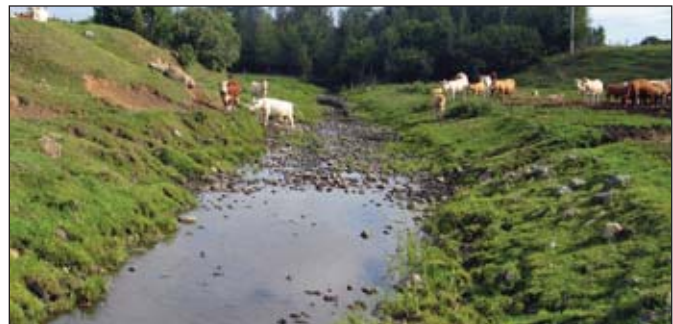
Photo 18: Trampling by livestock
Source: Mikael Guillou, MAPAQ

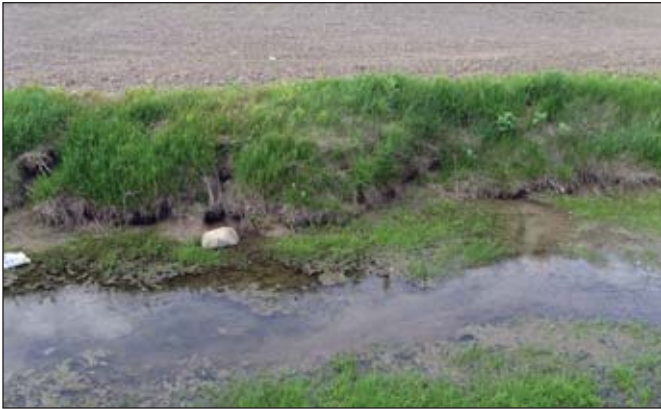
Photo 19: Burrows in banks
Source: Nicolas Stampfli

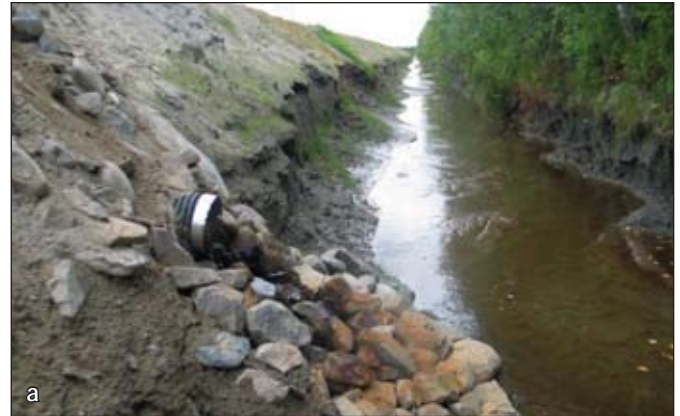
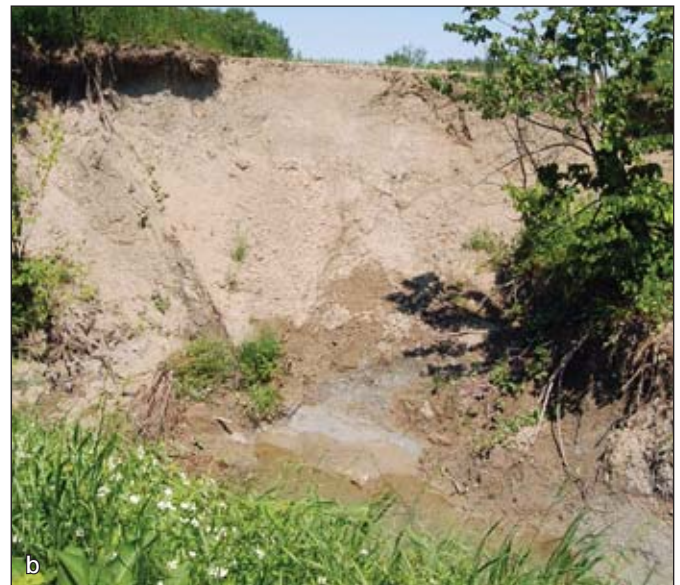
Photos 20 (a and b): Piping
Source: Victor Savoie, Robert Beaulieu, MAPAQ
